# **NASA Contractor Report 165300**

## **THERMAL FATIGUE BEHAVIOR OF H-13 DIE STEEL FOR ALUMINUM DIE CASTING WITH VARIOUS ION SPUTTERED COATINGS**

**C. Y. Nieh and J. F. Wallace**

**Case Western Reserve University  
Cleveland, Ohio**

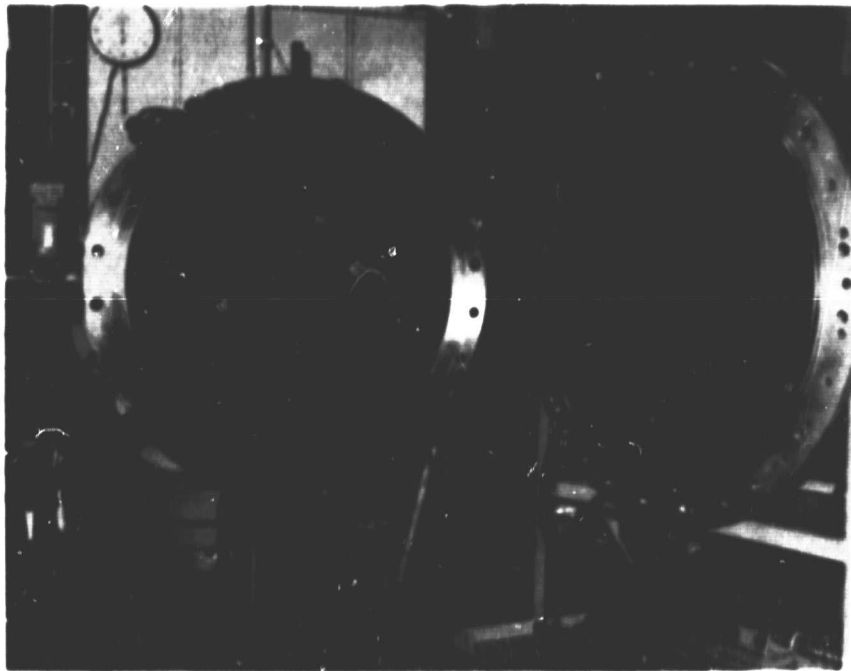
FIGURE 7: THE ACTUAL VIEW OF ION BEAM SPUTTER DEPOSITION EQUIPMENT.

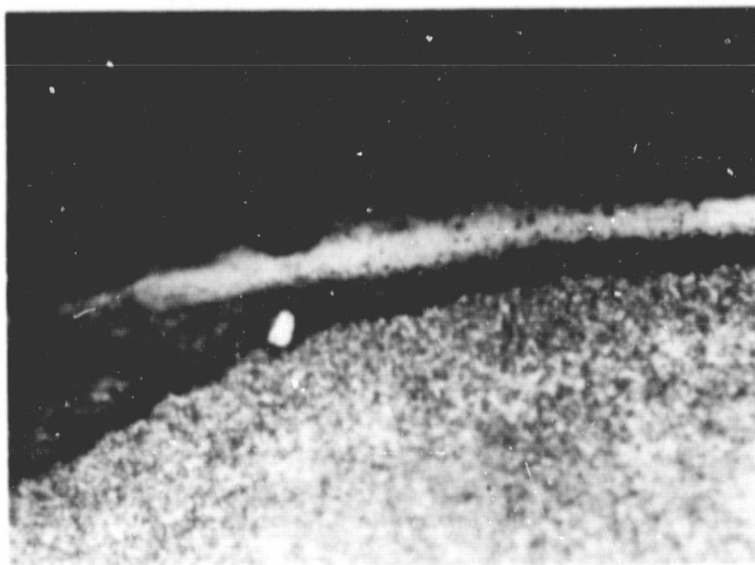
FIGURE 13: (a) THE TRANSVERSE VIEW OF THE CONTROL SPECIMEN. LIGHT GRAY AREA IS OXIDE LAYER COVERED ON THE MATRIX (WHITE AREA). (b) SAME AREA ETCHED BY 4% NITAL, NOTE THE AREA NEARBY THE OXIDE LAYER IS MORE REACTIVE TO ETCHING SOLUTION. (MAG 500X)

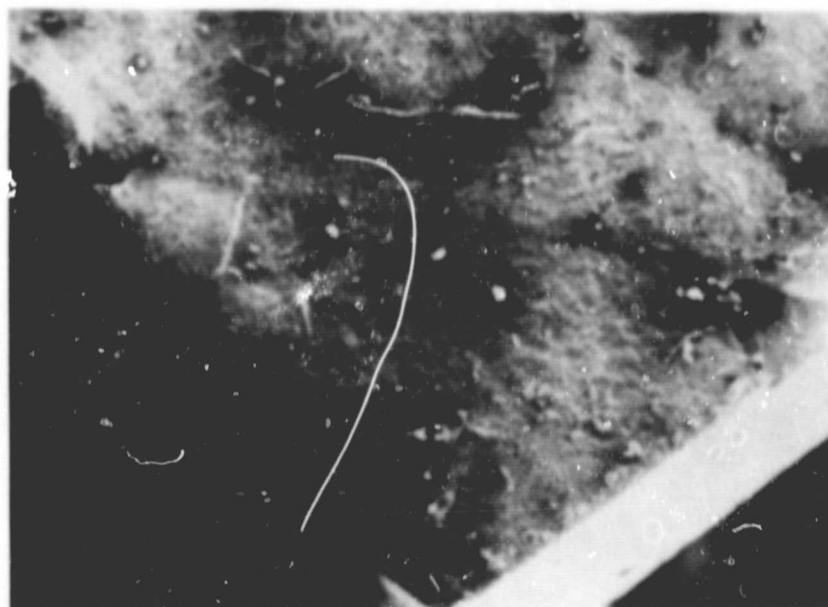
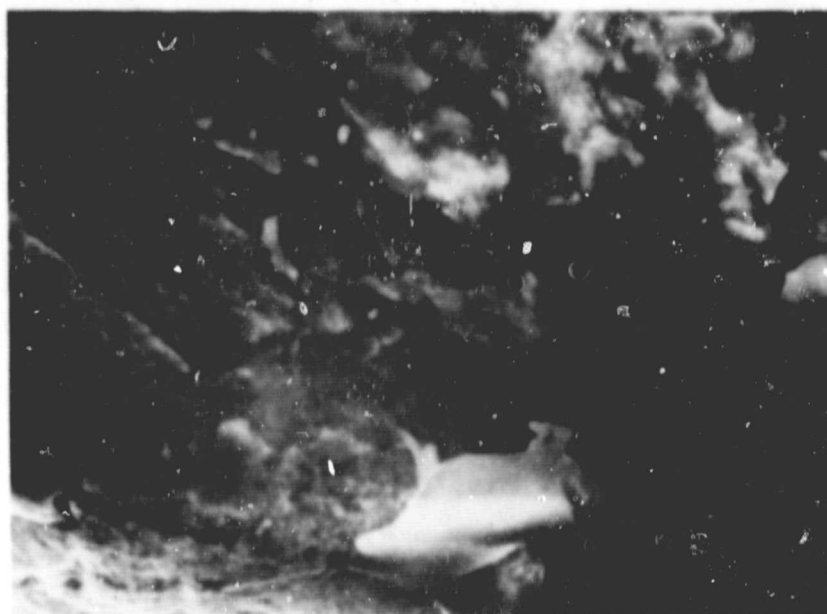
FIGURE 21: SEM MICROSCOPY OF TRANSVERSELY FRACTURED SURFACE OF PLATINUM COATED SPECIMEN. (a) CORROSION ATTACKED AREA OF THE THERMAL FATIGUE CRACK ARE OBSERVED. (b) AN ENLARGED VIEW OF TOP PICTURE IN AREA AROUND THE CORNER, OXIDE SCALE COVERED THE FRACTURED SURFACE ARE OBSERVED.

Figure 21 shows a low- and a high-magnification SEM photograph of the fractured surface of a crack in the corner of a platinum-coated specimen. Aluminum oxide covered the crack opening and the surface area of the fractured oxide, as observed in figure 21. A SEM photograph taken at the crack tip of a fractured specimen shows some of the oxide and the brittle fracture of the oxide. Similar behavior was noted at the corner of the control specimen illustrated in figure 22.

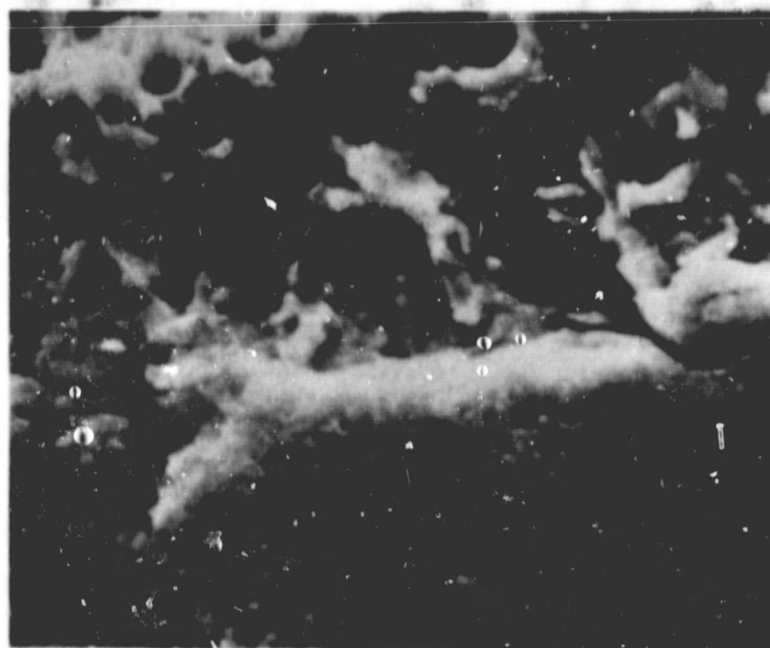
FIGURE 22: SEM MICROSCOPY OF CRACK FRONT OF CONTROL SPECIMEN. (a) THE BRITTLE CHARACTERISTICS OF OXIDIZED AREA AT LOWER PART OF THE PICTURE ARE OBSERVED. (MAG 1000X). (b) AN ENLARGED VIEW OF SAME AREA AS (a). (MAG 5000X)
